LTPP Seasonal Monitoring Program

Site Installation and Initial
Data Collection

Section 893015 Trois-Rivieres
Quebec

Report No. FHWA-TS-94-89-01

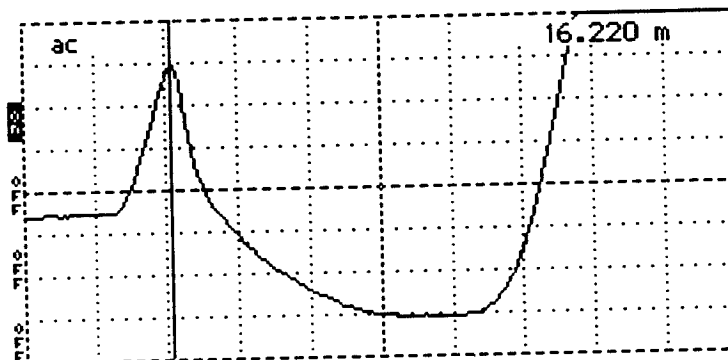
Trace Number 4 - Probe in Alcohol

Cursor 16.220 m
 Distance/Div..... .25 m/div
 Vertical Scale.... 48.6 m ρ /div
 P 0.99
 Noise Filter..... 1 avg
 Power ac

Tektronix 1502B TDR
 Date 9/12/93
 Cable #1
 Notes in methyl
alcohol
 Input Trace _____
 Stored Trace _____
 Difference Trace _____

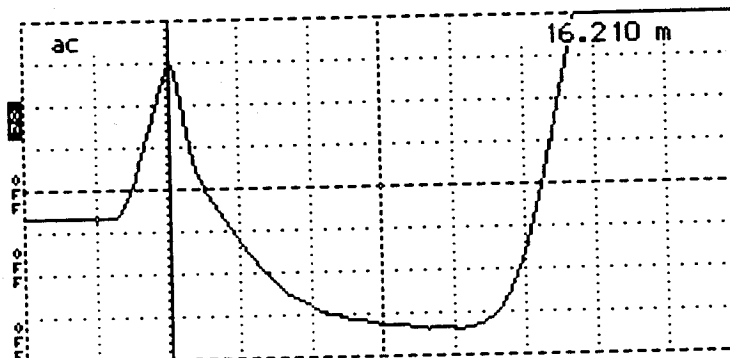
Trace Number 4 - Probe in Alcohol

Distance 16.210 m
 Distance/Div25 m/div
 Vertical Scale 47.2 mP/div
 0.99
 Filter 1 avg
 Filter ac

Tektronix 1502B TDR
 Date 9/12/93
 Cable #2
 Notes alcohol
 Input Trace _____
 Stored Trace _____
 Difference Trace _____

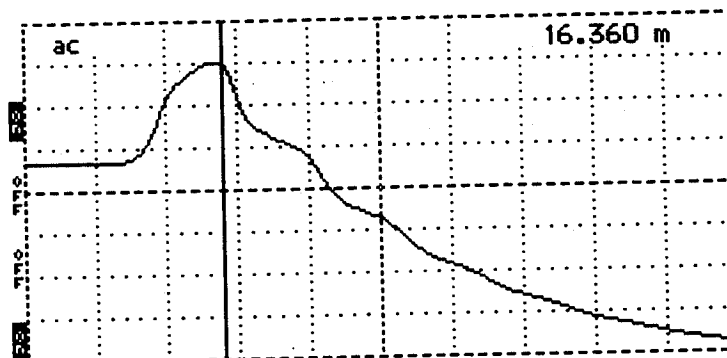
Trace Number 2 - Ending Probe Shorted

Cursor 16.360 m
Distance/Div25 m/div
Vertical Scale.... 167 mV/div
VP 0.99
Noise Filter..... 1 avg
Power ac

Tektronix 1502B TDR

Date 9/12/93
Cable #6
Notes Shorted @ end

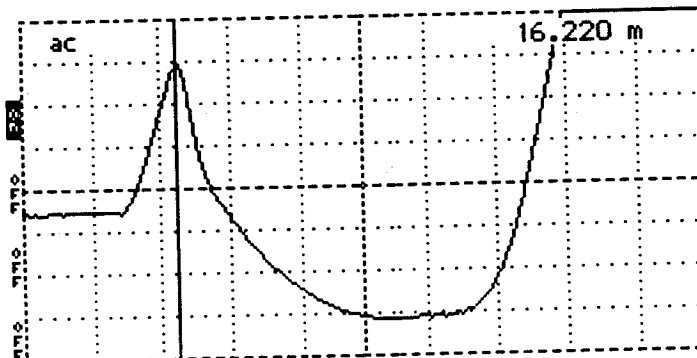
Trace Number 4 - Probe in Alcohol

Cursor 16.220 m
 Distance/Div25 m/div
 Vertical Scale 48.6 mP/div
 0.99
 Noise Filter 1 avg
 Power ac

Tektronix 1502B TDR
 Date 9/12/93
 Cable #7
 Notes alcohol
 Input Trace _____
 Stored Trace _____
 Difference Trace _____

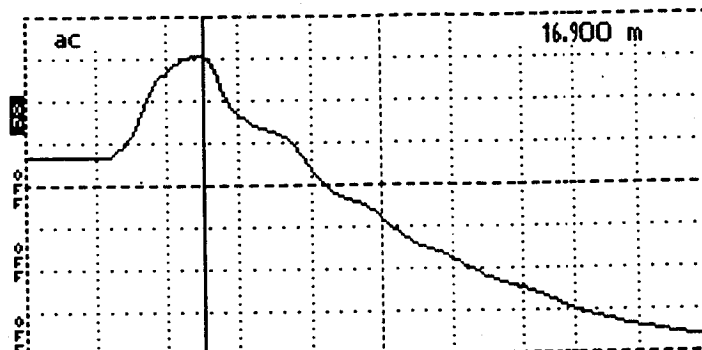
Trace Number 2 - Ending Probe Shorted

Cursor 16.900 m
Distance/Div25 m/div
Vertical Scale 167 mV/div
VP 0.99
Noise Filter 1 avg
Power ac

Tektronix 1502B TDR
Date 9/12/93
Cable #9
Notes Shorted @ end
